# PROJECT CASE STUDY

*The Post Building Condominium  
Asbury Park, NJ*

*Stone Facade Restoration*

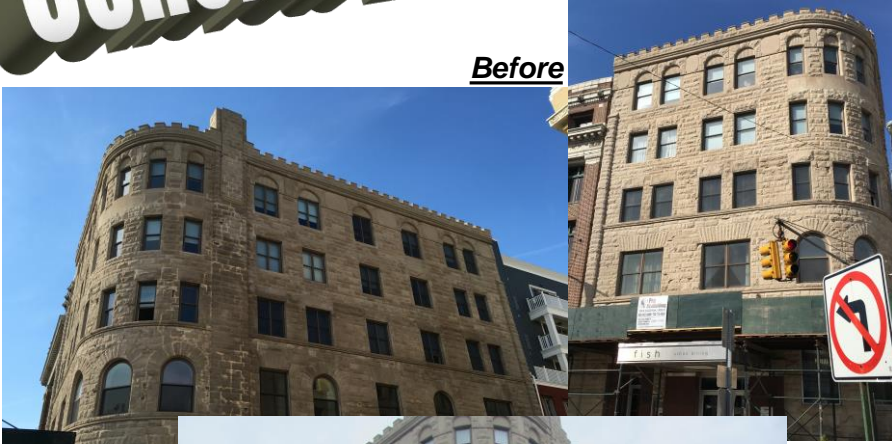
Before

Working with the Property Management team, Aquarius Restoration was hired to perform the repair and restoration of the stone facade. The restoration consisted of replacing the sections of deteriorated and spalled stone and replacement of the failed mortar joints. The biggest challenge was to match the stone color and texture to the original stone façade. Which we accomplished.

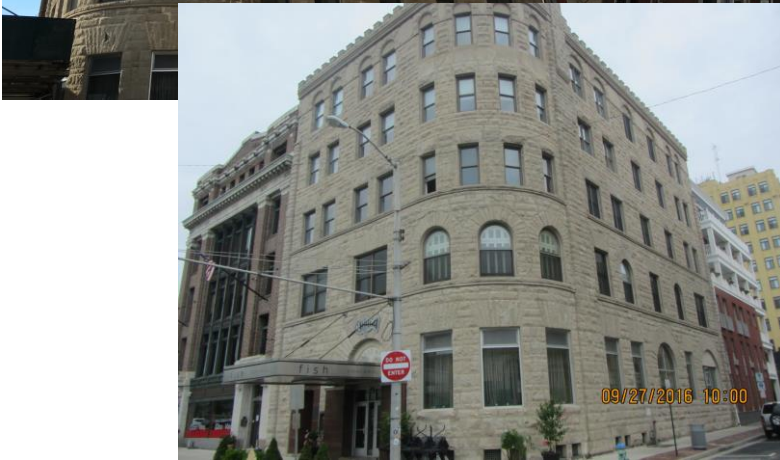
After

Once completed the façade was restored to it's original aesthetic beauty and functionality.
